Creating Safety, Courting Disaster on the Lower Shinano River, Japan

Philip C. Brown

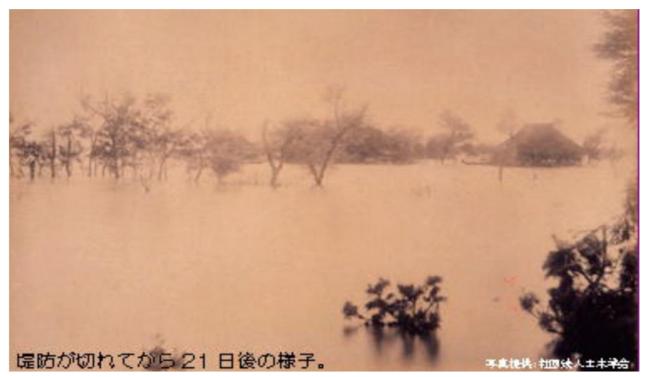
Stagnant floodwaters 21 days after the 1896 flood

On 26 July 1896, after days of rain, the waters of the Shinano River broke through the dikes at Yokota village (southwest of Niigata City) on the Echigo Plain, causing massive flooding. Stagnant water soaked the land for weeks. That event sparked the construction of an overflow channel first proposed in the 1730s, the Okotsu Diversion Channel (Okotsu Bunsui). Today many residents regard it so highly that they have proposed nominating the entire Echigo Plain as a UN cultural heritage site.

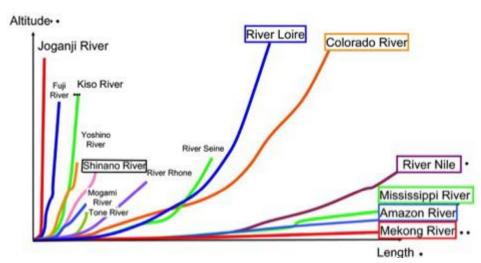
Comparison of Japanese and selected world river gradients

Japan's longest river, the Shinano, surges down a steep gradient, steeper than a number of the world's great streams. It empties onto the broad, flat Echigo Plain, historically subject to floods. Risk is amplified by the great variation between peak, minimum, and average volumes of water.

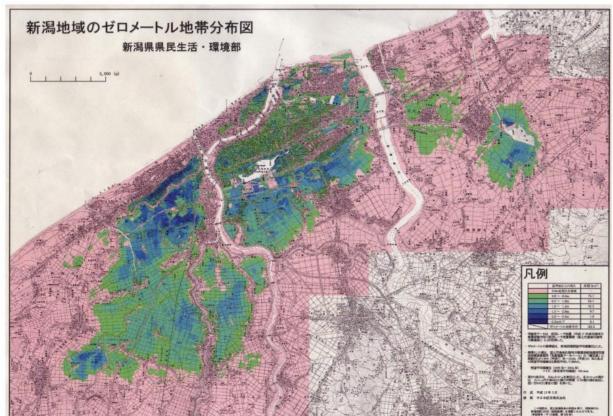
Patterns of subsidence, Niigata City: Blue and green areas are below sea level, the darker the color, the further they are located below sea level

By redefining risky areas as safe, policy makers sought (successfully) to promote investment, which itself created new inundation risks from subsidence. After Nagoya, Niigata City is the fastest-sinking area of Japan. The primary cause? Increasing population and industrial density lead to more and more subsurface water being pulled up from underground. Much of the city today is below sea level. The smaller stream shown on the map is the Shinano and its drainage channel, along which are pink areas above sea level, the result of modern dike construction that elevates the riverbed above the surrounding land. What will happen if one of the larger dikes break, as others have done?

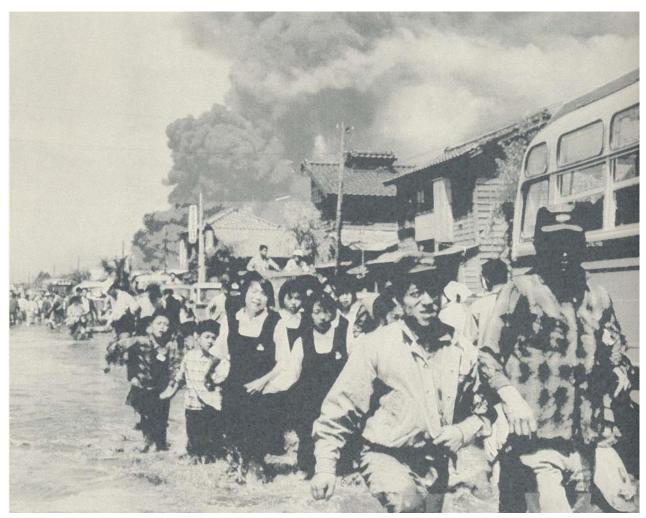
Tsunami-inundated Niigata City, 1964. This image was provided by Niigata Nippo Sha.

Further, residents of this area are subject to a special flood risk, from tsunami events, the impact of which is aggravated by subsidence linked to investments in newly identified safe areas. The tsunami caused by the 1964 earthquake surged far into the city. The waters did not drain for several weeks. With increased subsidence, more areas of the city will be at risk for inundation.
