The Search for George DeBaptiste's House: The Crooked Creek Flood of 1846

Christopher Baas and Darrin L. Rubino

We used archival sources and Geographic Information Systems data to demonstrate the feasibility of the 1846 Crooked Creek Flood (Madison, Indiana, USA) having destroyed the home connected to abolitionist and Underground Railroad leader George DeBaptiste.

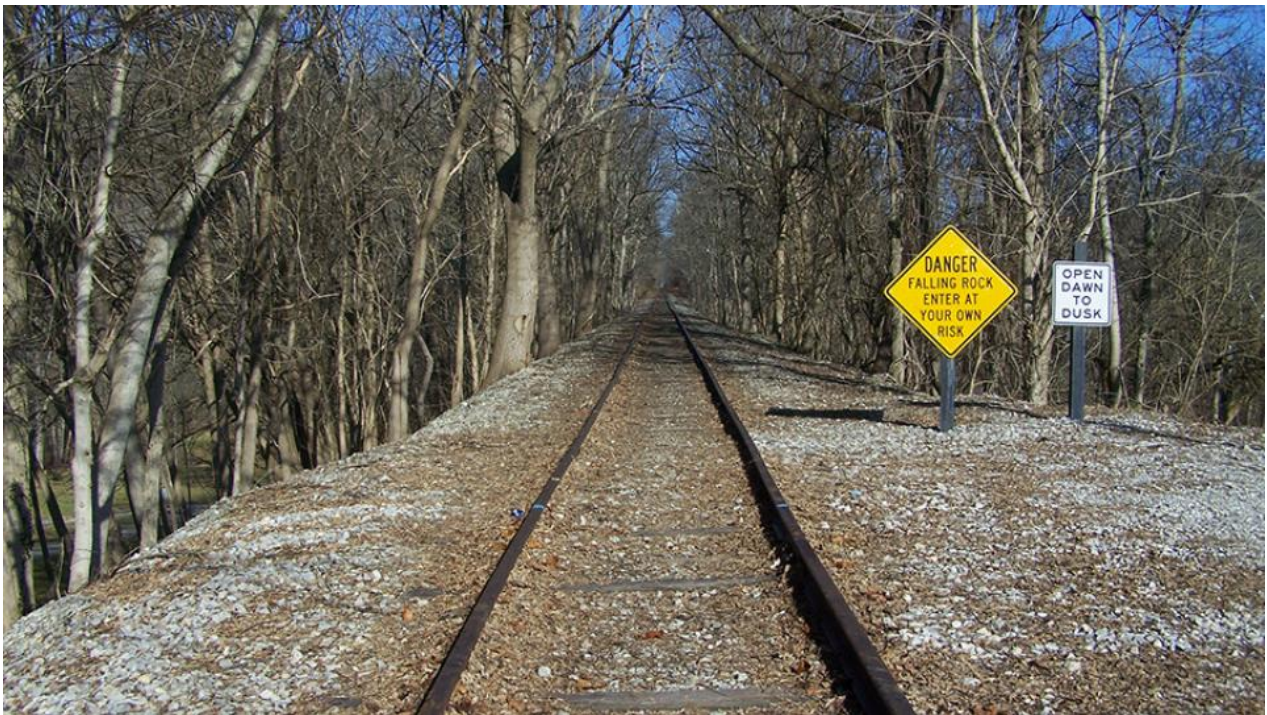
Photograph of the Madison, Indianapolis & Lafayette Railroad incline looking north.

The Madison, Indianapolis & Lafayette Railroad is the state’s first railroad (1841), and infamous for its “incline,” a section of track with the steepest slope of any railroad in the country (412 meters rise over 2.1 kilometers of track). Construction required the removal of as much as 38 meters of limestone. To establish a consistent slope from the city to the bluff top, Crooked Creek valley was filled with nearly 21 meters of stone and soil; the creek was channeled in a culvert beneath the embankment.
