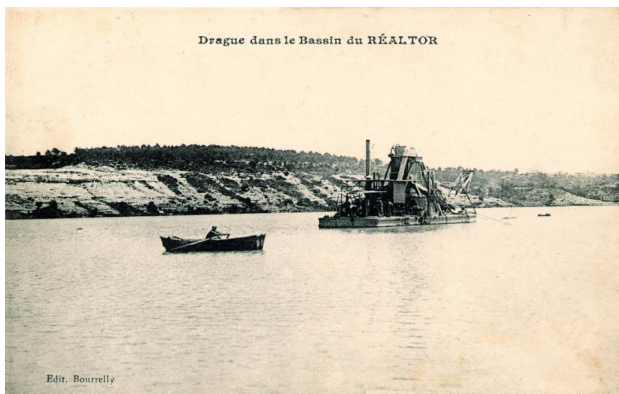
Barge-mounted hydraulic dredge operating at the surface of a storage and sedimentation reservoir originally built along the Canal de Marseille: the Réaltor reservoir (early twentieth century)

Yet, five storage and sedimentation reservoirs had been originally built along its course in order to allow deposition of sediments before water distribution. But, as suspended sediment fluxes were strongly underestimated, these infrastructures, badly designed with very low capacities, were no longer usable after a few years. The first collapsed and the other four silted more or less rapidly before being decommissioned; only one reservoir—the Réaltor—continued to function but in a very limited way. Recurrent desilting campaigns of this last one did not yield the expected results and did not ultimately prevent its almost total siltation.
